RCRA Facility Assessment ENPRO Services of Maine, Inc.

RCRA FACILITY ASSESSMENT REPORT

ENPRO Services of Maine, Inc. MED 019 051 069

106 Main Street South Portland, Maine

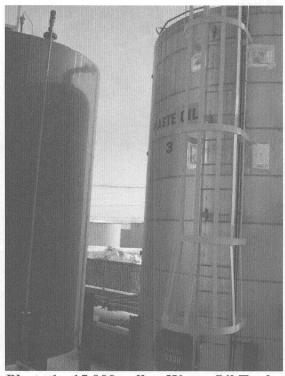
In 1992 the tanks were replaced. Waste oil is currently stored in three 15,000-gallon ASTs located in a concrete bermed area at the rear of the facility. The waste oil ASTs are 24 foot tall steel tanks with level indicators. This waste is shipped off-site on hazardous waste manifests to a facility that reuses the waste gasoline.

During the VSI, the sumps and secondary containment were observed to be empty and clean, and the concrete floors and walls were in good condition with minimal staining present.

Photo 1: 15,000 gallon Waste Oil Tanks

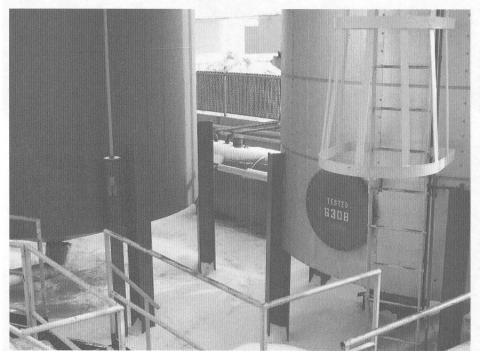
Photo 2: 15,000 gallon Waste Oil Tanks and 1,000 gallon Heating Oil Tank

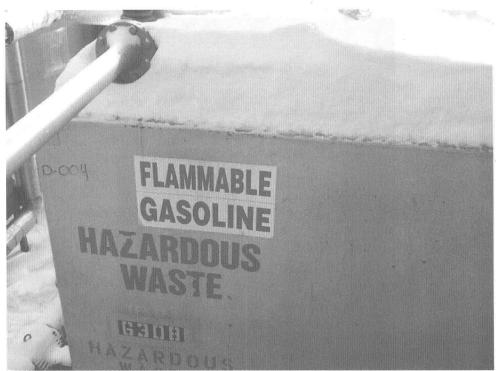
Waste gasoline is stored in a 6,000-gallon AST also located within the bermed area. The waste gasoline tank is a square double walled steel tank with continuous leak detection operating within the interstitial space. The outside of the gasoline tank is surrounded with approximately four inches of reinforced concrete and sealed in a steel outer tank.

There have been no releases reported in connection with the operation of this area. At the time of the VSI, this unit was in good condition. No stains were noted on the floor, and the concrete was in good condition. There was no evidence of previous spills inside the secondary containment areas.

Photo 3: 6,000 gallon Gasoline Storage Tank

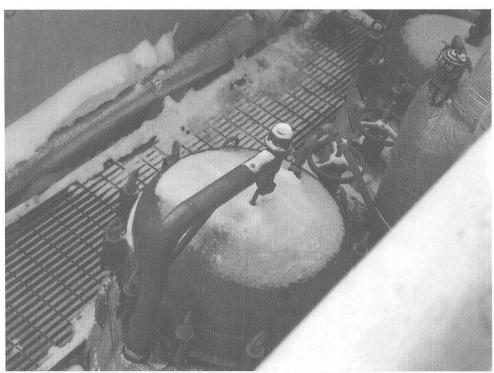
Photo 4: Tank Heating System and Sump

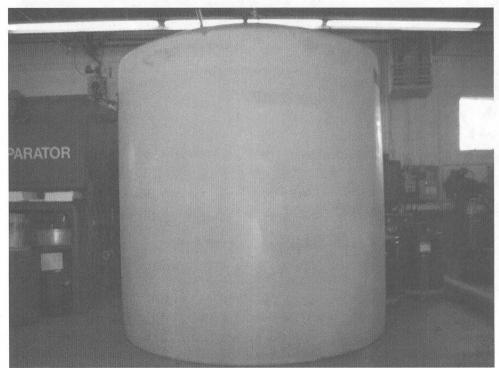
A number of the steel tanks were replaced with HDPE tanks in 2007 to prevent corrosion impacting the system. The system is in good operating condition.

Photo 5: Wastewater Treatment System, Storage Tank

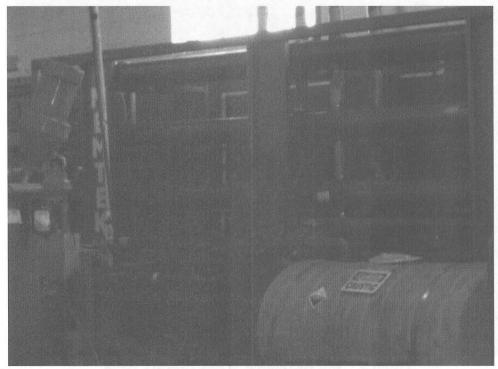
Photo 6: Wastewater Treatment System, Membrane Filters, Mixing Tank

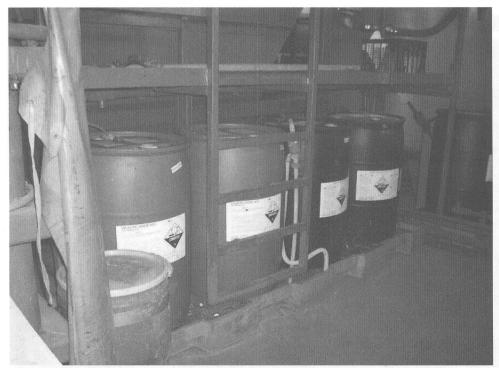
Photo 7: Wastewater Treatment System, Chemical Addition

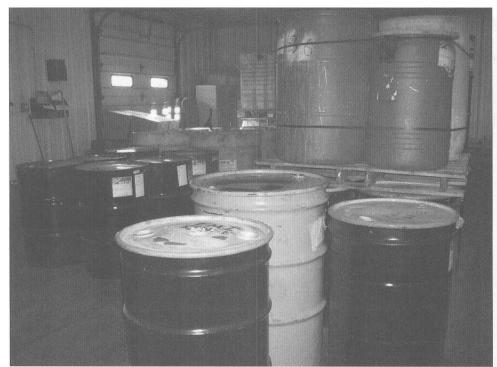
Non-hazardous waste drums are stored in the back room of the building. According to the license, drums can be stored in 7 separate rows, with up to 16 drums per row, with 3-foot wide aisles in between the drums. Drums are not stored on secondary containment, however, the floor of the room is sloped, with an epoxy coating, and there is a 10-inch concrete berm surrounding the entire room to prevent spills from reaching outside.

Photo 8: Non Regulated Waste Storage Area

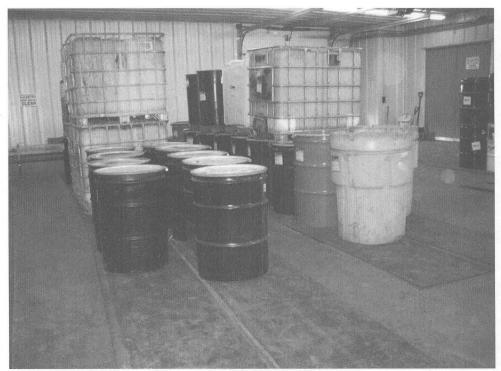
Photo 9: Non Regulated Waste Storage Area

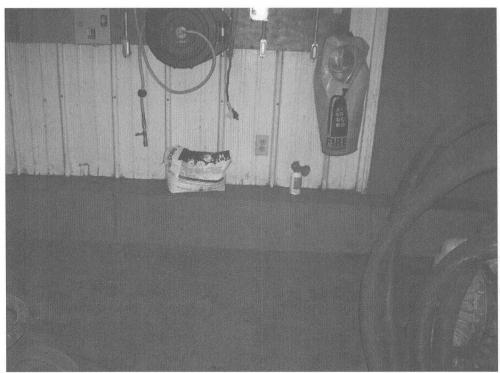
The interior of the facility is constructed of concrete slab on grade. The concrete floors within the treatment and storage areas are sloped and surrounded by a 10-inch tall berm wall constructed of cement block and cement and provide leak protection around the entire footprint of the building.

Photo 10: Secondary Containment Around Entire Building

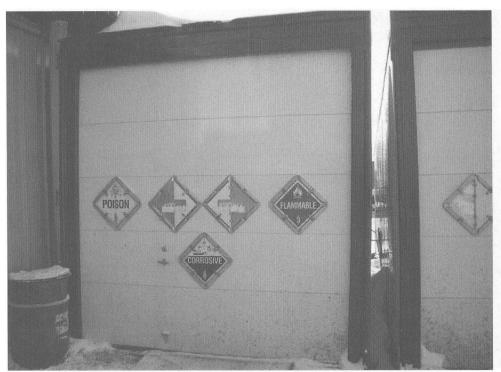
The hazardous wastes are stored in transfer trailers located next to the loading dock. These trailers are 48-foot to 53-foot self-contained trailers parked on top of asphalt pavement. The exterior of the trailers is constructed of coated wood. The interior has been retrofitted with a secondary contaminant system consisting of a steel diamond plate floor, with a 10 inch wall plate welded to the floor plate on three sides of the trailer. The back of the trailer has a removable plate which is fitted with a leak tight gasket. The gate is only removed to allow for loading and unloading of waste. Additionally, waste drums are stored on plastic containment pallets as an additional precautionary measure.

Photo 11: 10-Day Storage Trailer, Exterior

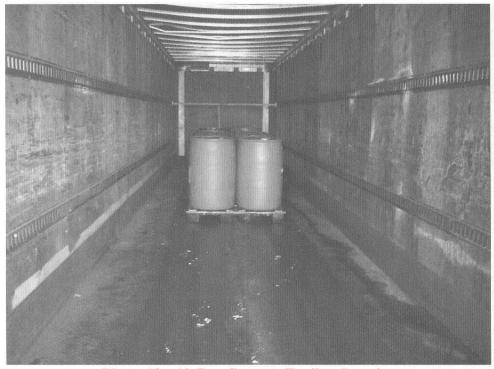
The transfer trailers are 48-foot to 53-foot self-contained trailers parked on top of asphalt pavement. The exterior of the trailers is constructed of coated wood. The interior has been retrofitted with a secondary contaminant system consisting of a steel diamond plate floor, with a 10-inch wall plate welded to the floor plate on three sides of the trailer. The back of the trailer has a removable plate which is fitted with a leak tight gasket. The gate is only removed to allow for loading and unloading of waste. Additionally, waste drums are stored on plastic containment pallets as an additional precautionary measure.

Photo 12: 10-Day Storage Trailer, Interior

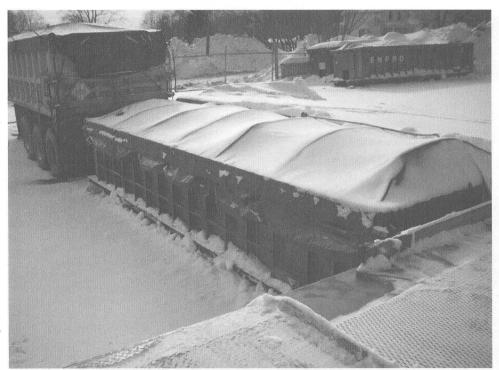
The roll-off bins are owned and operated by ENPRO. The bins contain non-hazardous solid oil-contaminated material and filter cake from the wastewater treatment system are located on concrete pads along the exterior of the building.

Photo 13: Solid Waste Roll Off Bin

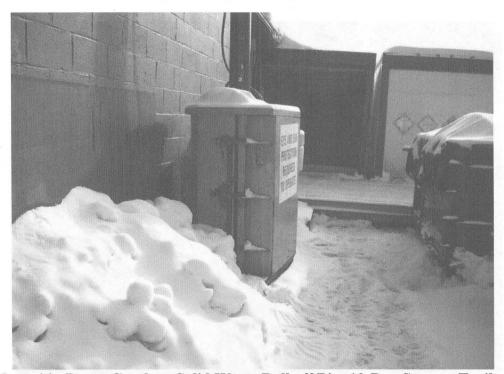
Photo 14: Drum Crusher, Solid Waste Roll off Bin, 10-Day Storage Trailers

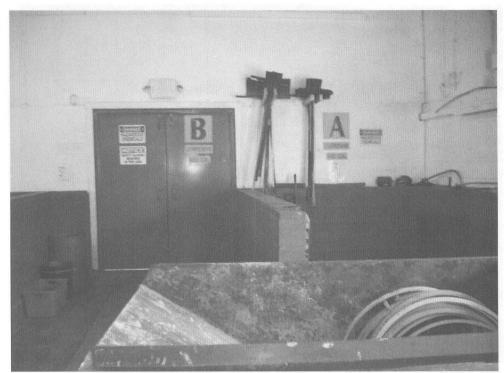
The area was lined in 1987 with epoxy coated metal and provided with a concrete wall separating the corrosive storage area from flammable storage, breaking the unit up into four cells. Additionally, there is a beveled concrete floor and bermed doorways to prevent leaks.

Photo 15: Former 10-Day Holding Area

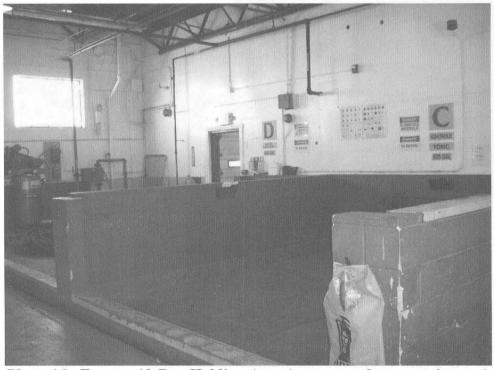
Photo 16: Former 10-Day Holding Area (note secondary containment)

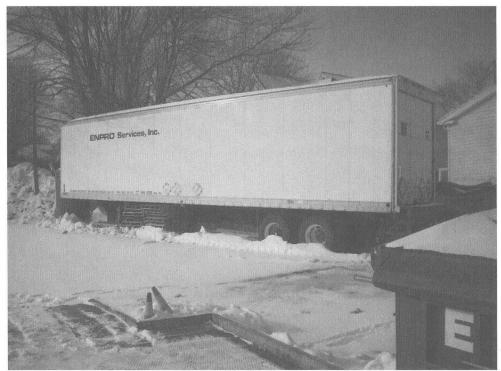
Photo 17: Paved Storage Yard, Entrance to Loading Area

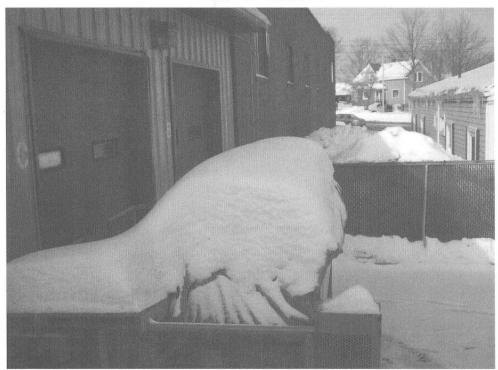
Photo 18: Loading Area, Adjacent ENPRO property at 100 Main Street
